### Arborist Report

SITE: Olympic Drive (SR 305) between Harborview Drive SE & Winslow Way E  
Bainbridge Island, WA 98110

RE: Inventory & Assessment of Trees in Area of Proposed Improvements

DATE: August 20, 2015

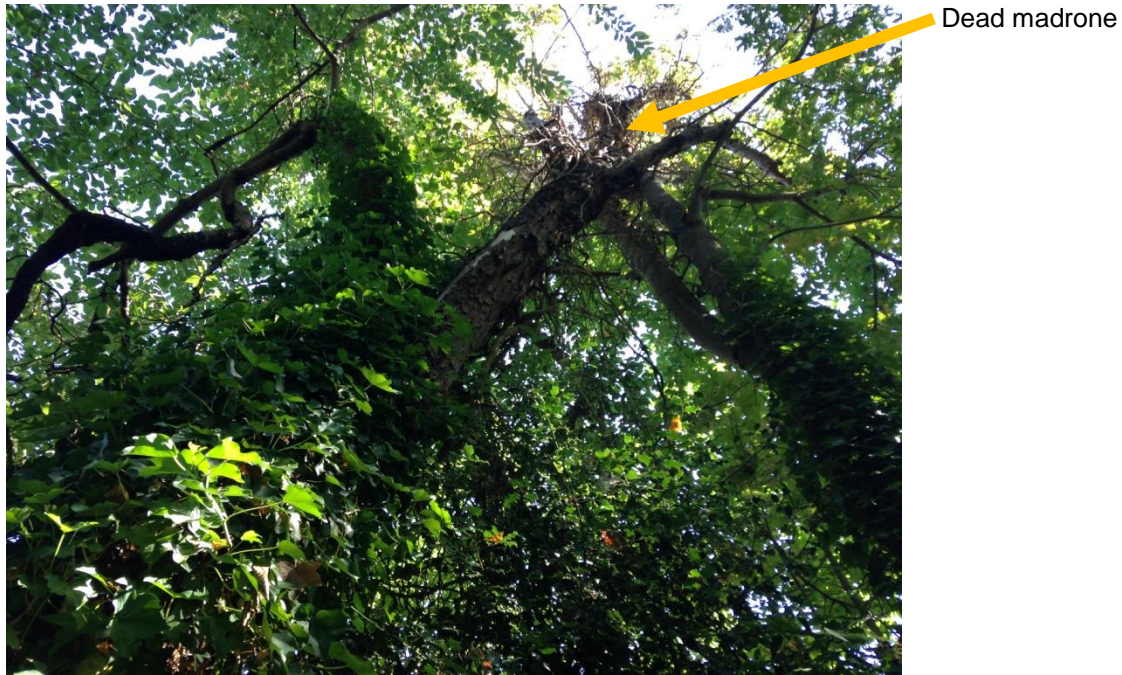
Photo 1: Trees 510 (left) & 511 (right) with dead madrone failed and lodged between – remove carefully.

509	<i>Alnus rubra</i>	Red alder	15.0			Fair	Poor	Remove	Heavy ivy coverage. Leans toward Olympic Drive.
510	<i>Prunus emarginata</i>	Bitter cherry	13.0			Fair	Poor	Remove	Severe basal cankers. Leans on dead madrone tree.
511	<i>Acer macrophyllum</i>	Bigleaf maple	16.0			Good	Fair	Remove	Ivy at base. Supporting dead/failed madrone tree.
512	<i>Arbutus menziesii</i>	Pacific madrone	16.0			Fair	Good	Remove	Heavy ivy coverage at base.
513	<i>Pseudotsuga menziesii</i>	Douglas-fir	34.0			Good	Good	Remove	Heavy ivy coverage at base.
514	<i>Acer macrophyllum</i>	Bigleaf maple	17.0			Good	Good	Possibly retainable	
515	<i>Acer macrophyllum</i>	Bigleaf maple	19.0			Good	Fair	Possibly retainable	Heavy ivy coverage at base.
516	<i>Acer macrophyllum</i>	Bigleaf maple	12.0			Fair	Fair	Remove	
517	<i>Acer macrophyllum</i>	Bigleaf maple	18.7*	4.0, 8.0, 10.0, 13.0		Fair	Fair	Remove	
518	<i>Acer macrophyllum</i>	Bigleaf maple	19.4*	8.0, 12.0, 13.0		Fair	Fair	Remove

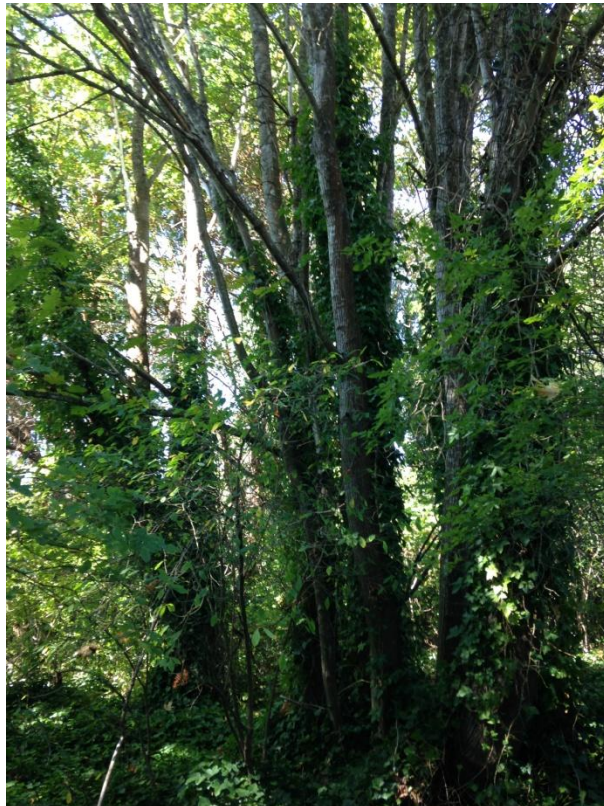
Photo 2: Clump of multi-stem maples to be removed from central site.

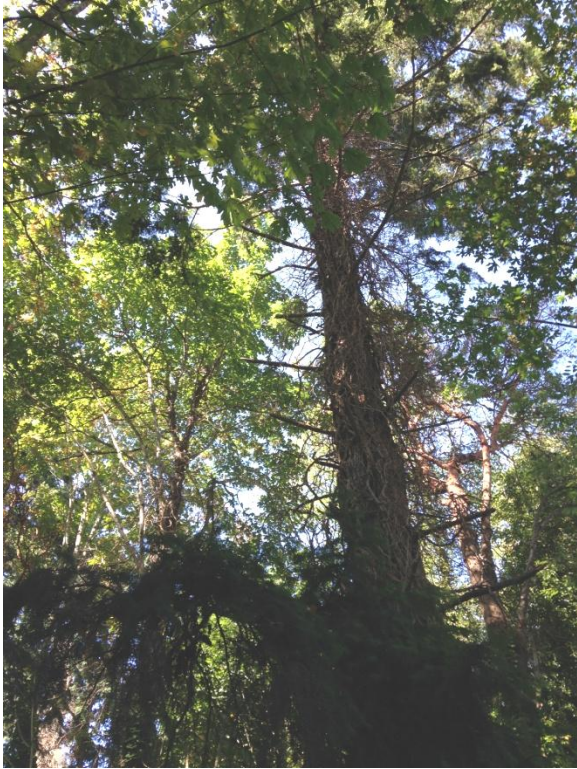
Photo 3: Douglas-fir 523 in foreground may be left partially intact as 20-25 foot snag to protect madrone behind.

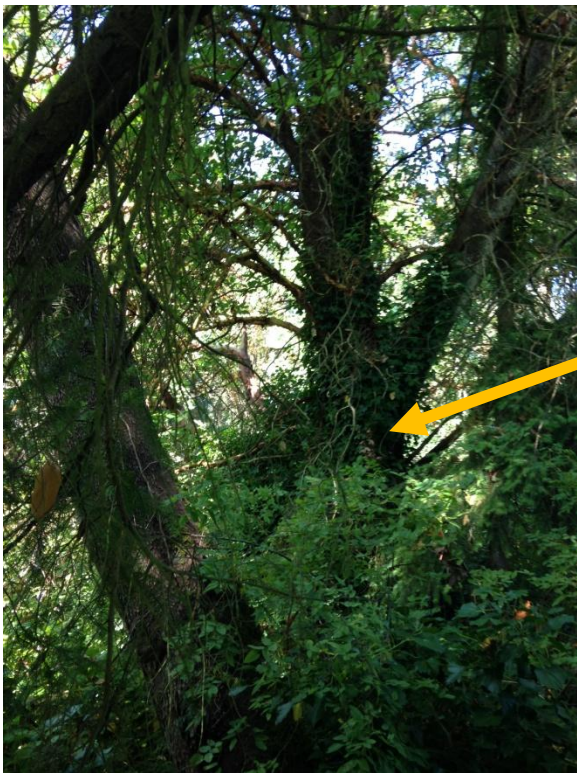
Photo 4: Madrone tree 527 pointed out by arrow is nice specimen which should be retained and protected.

527	<i>Arbutus menziesii</i>	Pacific madrone	37.4			Good	Good	Retain & protect	Drip line radius 24 feet to northeast.
528	<i>Pseudotsuga menziesii</i>	Douglas-fir	18.0			Good	Fair	Retain & protect - buffer for 527	Odd basal form - possible burl?

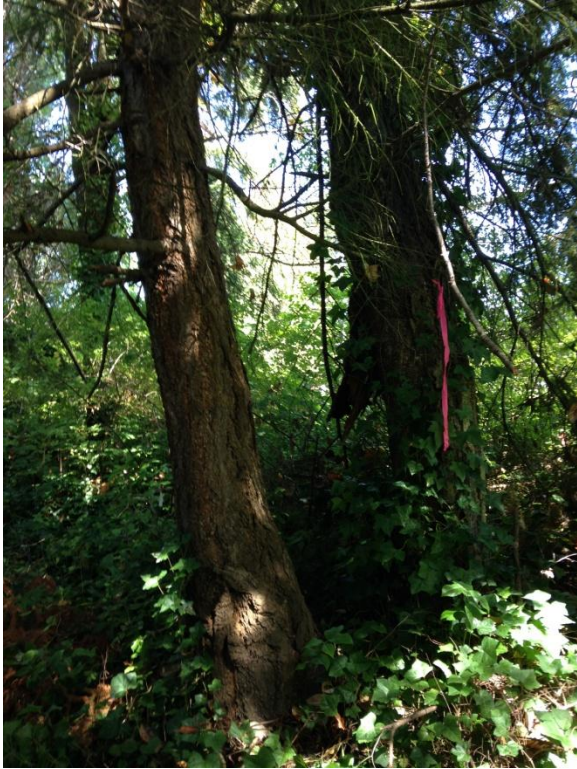
Photo 5: Douglas-fir tree to right appeared to be in the process of failing – this tree was not tagged, as it is well outside of the work zone, but we feel it should be removed for safety. Adjacent tree in foreground may need to be assessed for altered exposure once hazard tree (marked with pink flagging) is gone.
